Waterman Fund Grant Report 2016 Cadillac Mountain South Ridge Trail Rehabilitation Acadia National Park

**Charles Jacobi, Natural Resource Specialist
Rebecca Flesh, Recreation Technician
Gary Stellpflug, Trails Foreman
December 2016
ANP Natural Resource Report 2016 - 1**

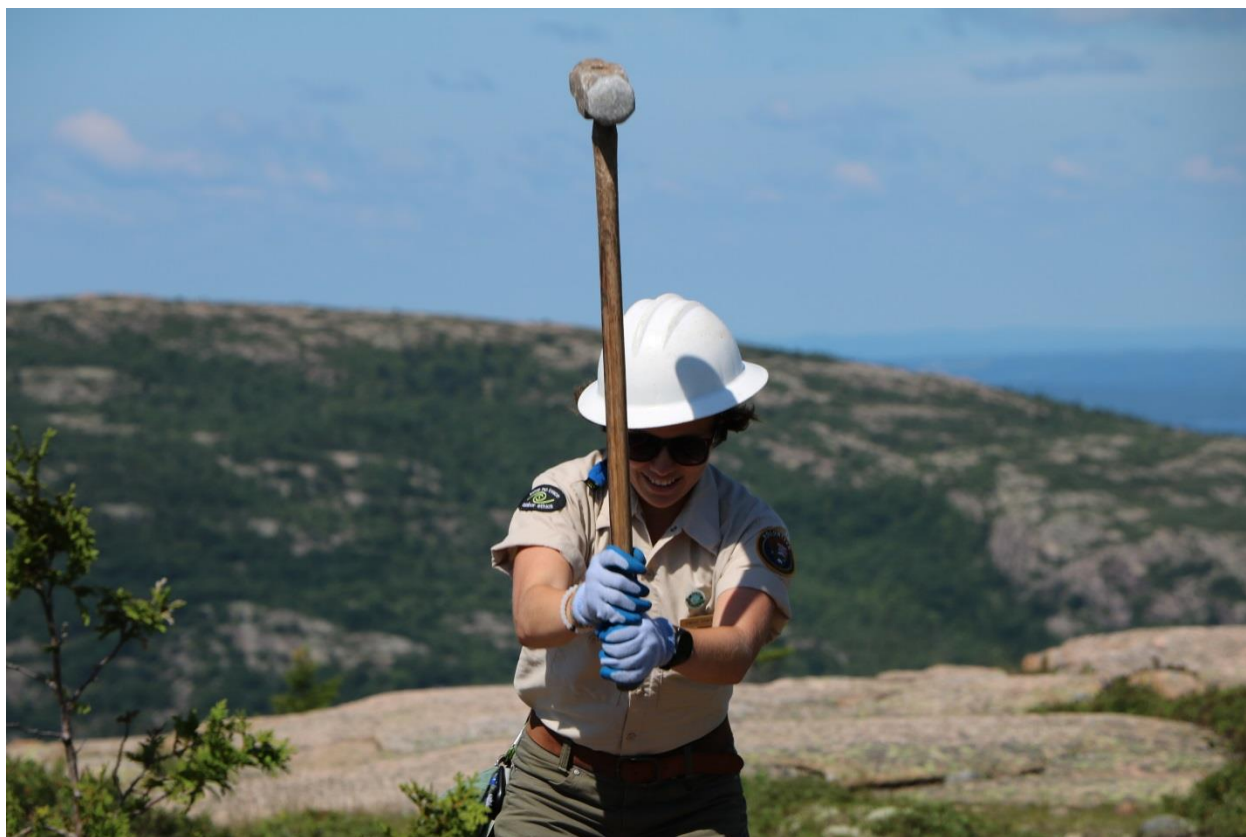
Sledging Rock for the Trail Tread

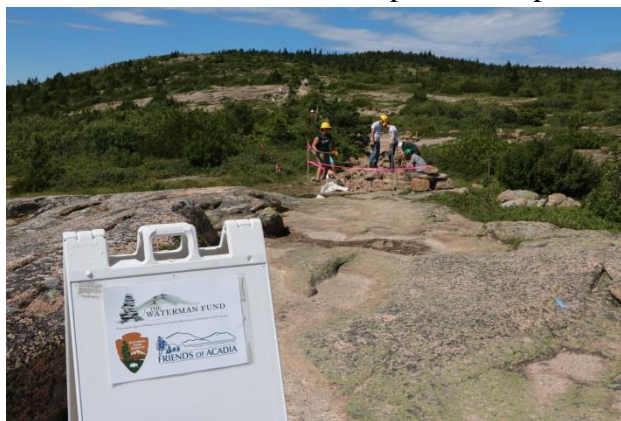
Figure 2: Temporary Sign

After the work was completed, we counted hikers and observed their behaviors at the same site on July 24 and 31, and August 8 and 11 for 8.5 hours and recorded the same data. For the post-rehabilitation observations, we removed several temporary signs shown in report images and replaced them when we finished observing. This allowed the trail work to stand on its own to help keep hikers on trails. These signs will probably be removed in a few years when the vegetation grows back more fully.

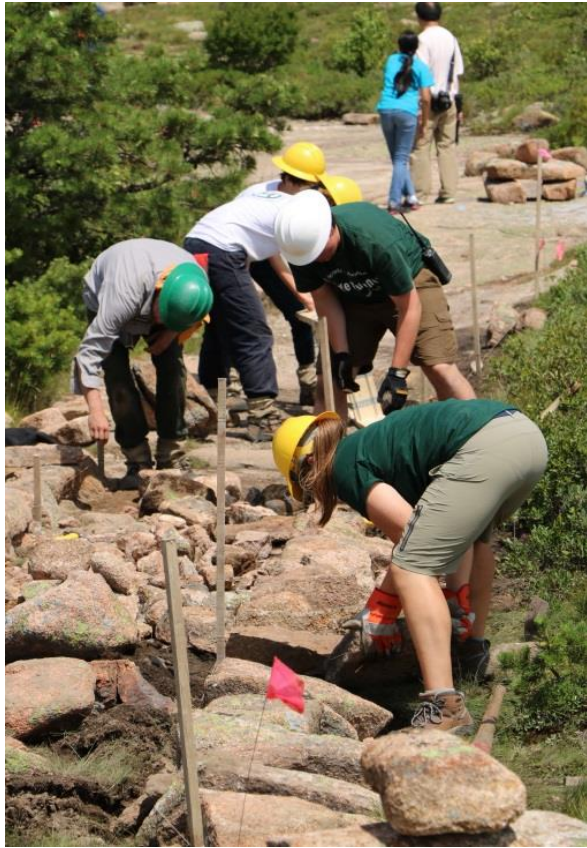
Figure 1: Setting Retaining Wall

Professional trail crew staff focused on setting solid retaining walls of large rocks to hold a rubble-filled causeway, assisted by Ridgerunners (Figure 3). Some vegetation and soil was removed during work and relocated to the previously impacted sides of the causeway. YCC crews and Ridgerunners moved big rocks for the retaining walls (Figure 4), removed smaller rocks from the nearby West Face Trail junction cairn (Figure 5), and crushed rocks to create material for the trail tread (Figure 6). Removing rocks from the large intersection cairn reduced the impacts of gathering or quarrying rocks from the surrounding environment.

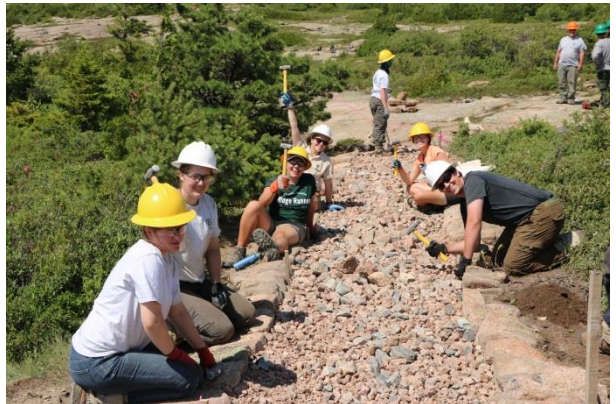
Figure 6: Rock Crushers

Anecdotally, we listened to several hikers complain about the tread we crushed, describing it as too hard to walk on because of its large size. Despite this, they stayed on it, perhaps simply because it was obvious. We note that most hikers today, including those we observed, wear low cut trail running shoes or sneakers with little ankle support. Hiking boots are not that common anymore.

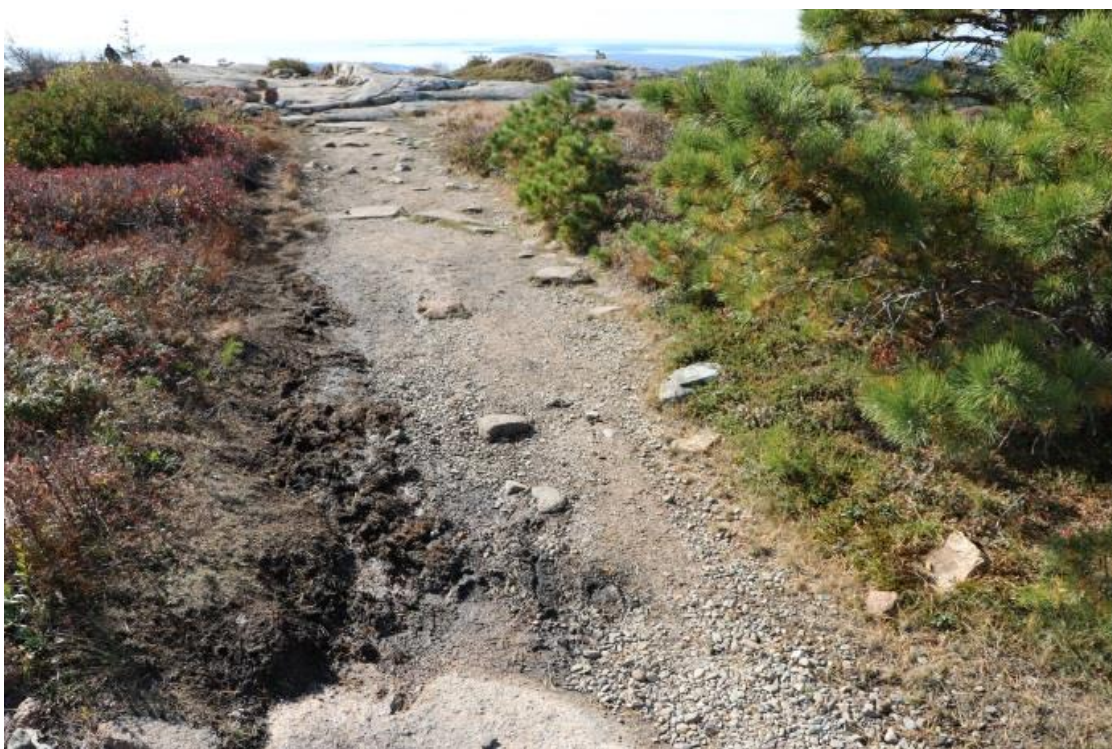
Figure 7: Cadillac South Ridge Trail, South Site October 2015

We created about 100 feet of rock-lined causeway in two distinct locations that clearly defined the trail, eliminating the standing water and mud that was there (Figures 7, 8, 9, and 10). We also rebuilt two cairns to better direct hiker traffic to one of the trail sections. Deer hair sedge (*Trichophorum cespitosum*) and mountain sandwort (*Minuartia groenlandica*), two species of growing concern in the park, are now better protected in the vicinity of the project.
